Rainier Commons LLC

Catch Basin Sampling Source Control Action Report

September 5th, 2014

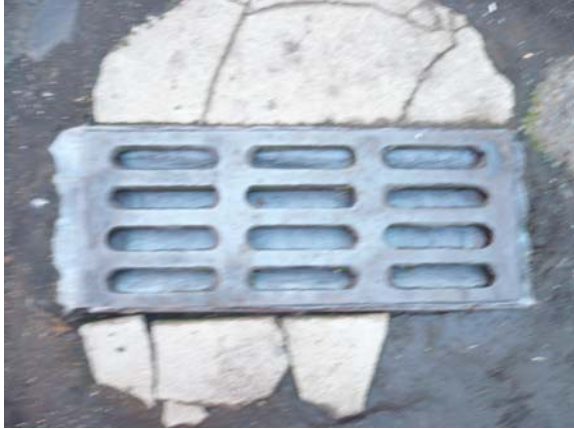
CB15(SD8) after cleaning 09.04.14

1. Catch Basin 15 and Manhole 8 located in the Courtyard, which flow into Manhole 6 were cleaned on September 4th, 2014 (Exhibit B).
2. Cleaning CB2, CB3 and CB4 from sediments and water is scheduled for Monday, September 8th, 2014. CB2 and CB4 flow into CB3.

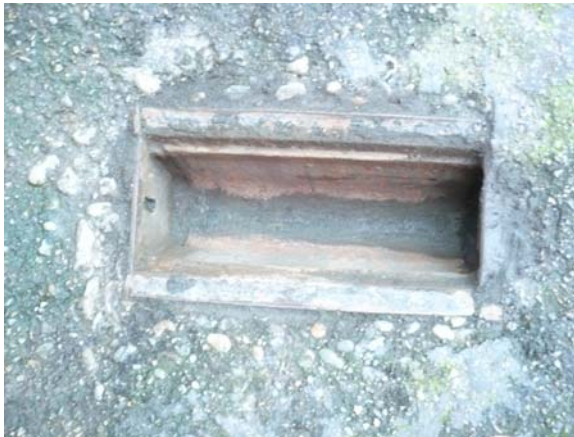
CB15(SD8) after cleaning 09.04.14

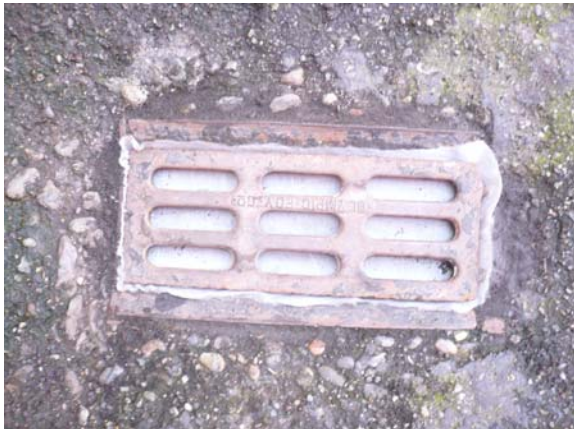
MH6(CB16) after cleaning 09.04.14

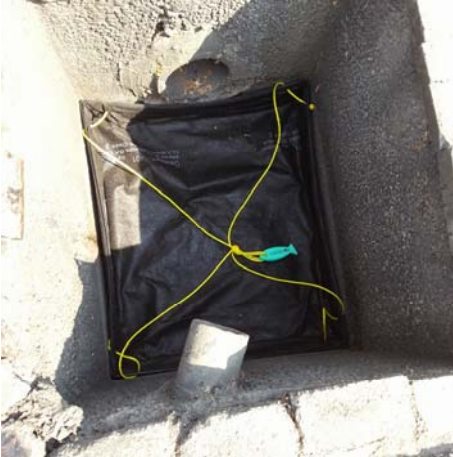
CB1 new "Catch All" is installed on 8.11.14

4. Installing new "Catch All" for CB1 and CB2. (Exhibit C)
5. The mislabeling of CB12 on MSI reports was acknowledge by MSI and will be reflect on new reports starting the week of August 18th, 2014. (Exhibit D)

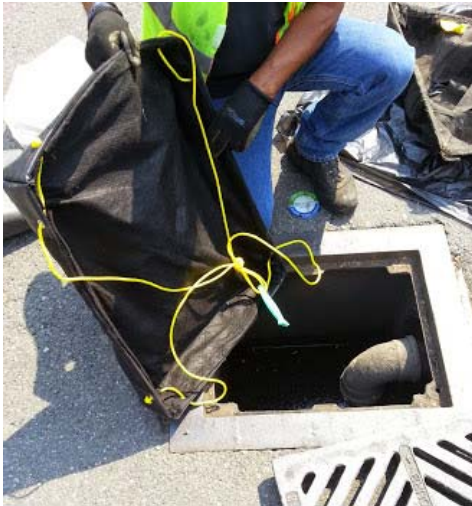
CB2 new "Catch All" is installed on 8.11.14
